**Guaranteed Home Inspections
800 579 5018**

**HOME INSPECTION REPORT
By Kurt Shafer
Inspector of Properties**

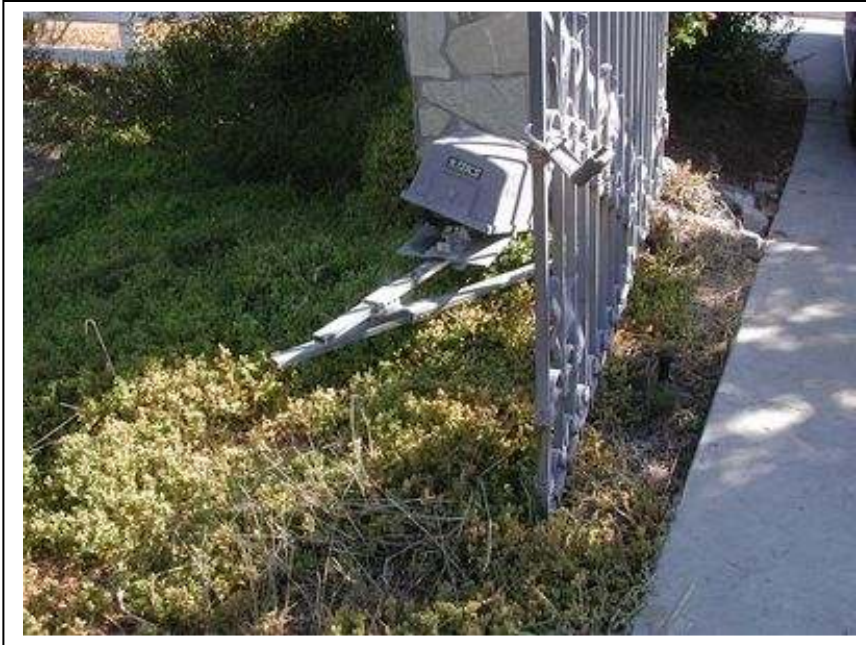
Figure 001. CR.H.2252. There are electrically operated gates at the driveway entrance that are in disrepair and do not move and the remote control for them was not found.

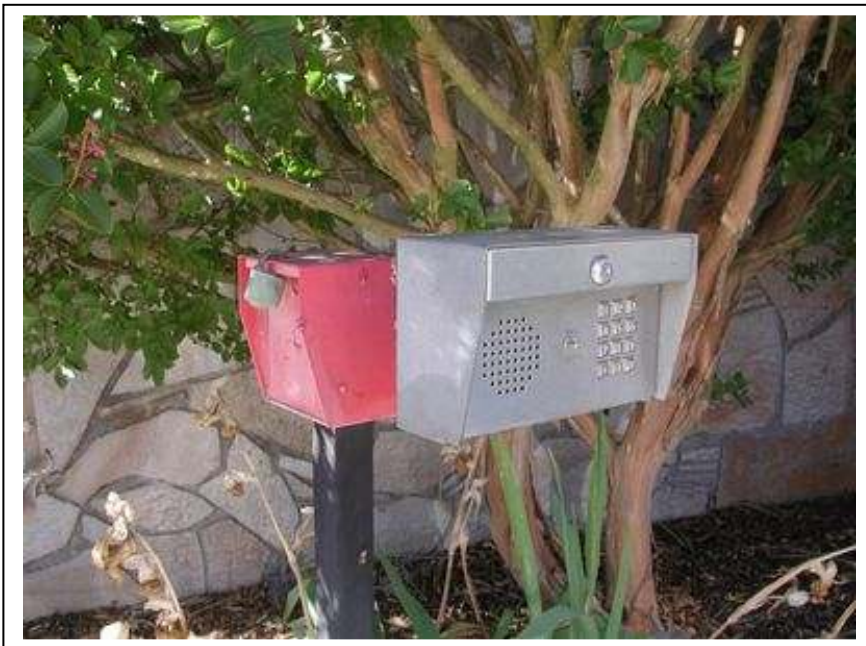
002. FE.C.2253. There is an intercom at the front entrance that could not be tested and there is a red box with a key that is likely for the fire department and should be investigated further.

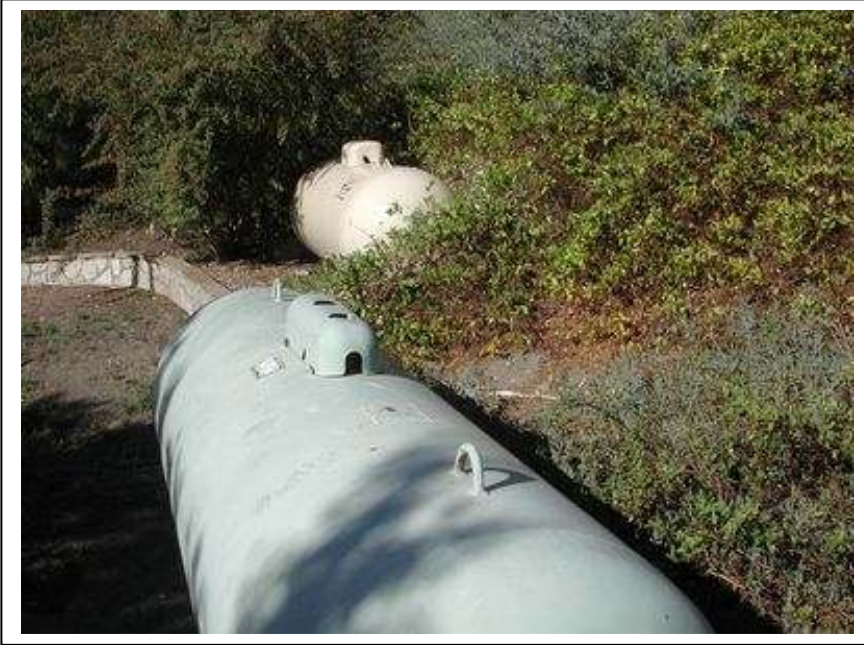
003. FE.C.2254. There are two propane tanks on the property, one which is not being used in the foreground and one that is for use in the background and the propane line is disconnected so it is recommended that the propane company connect propane and then test all of the gas loads in the house that were not tested during this inspection.

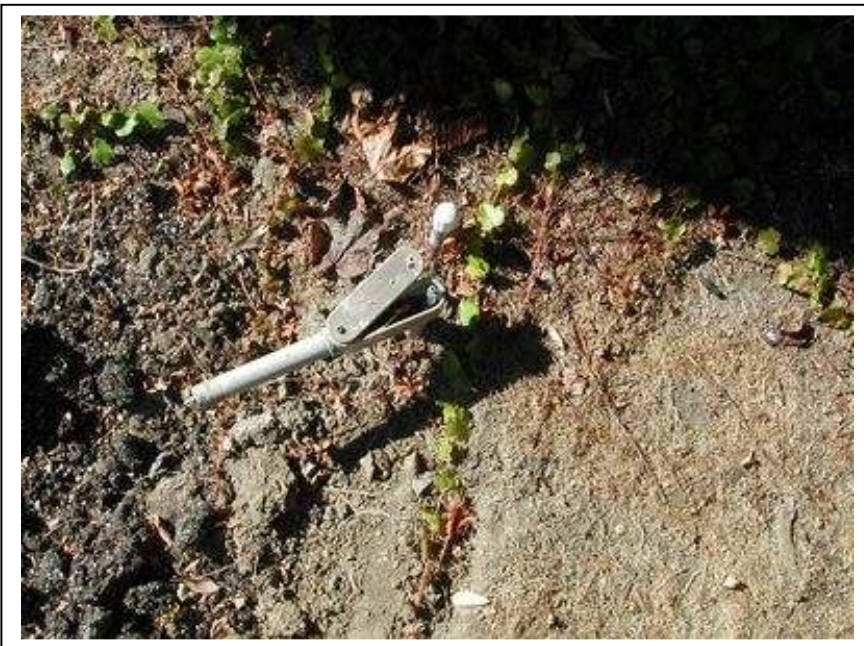
004. CR.E.2258. Near the front of the house is an AC conduit with an open cover.

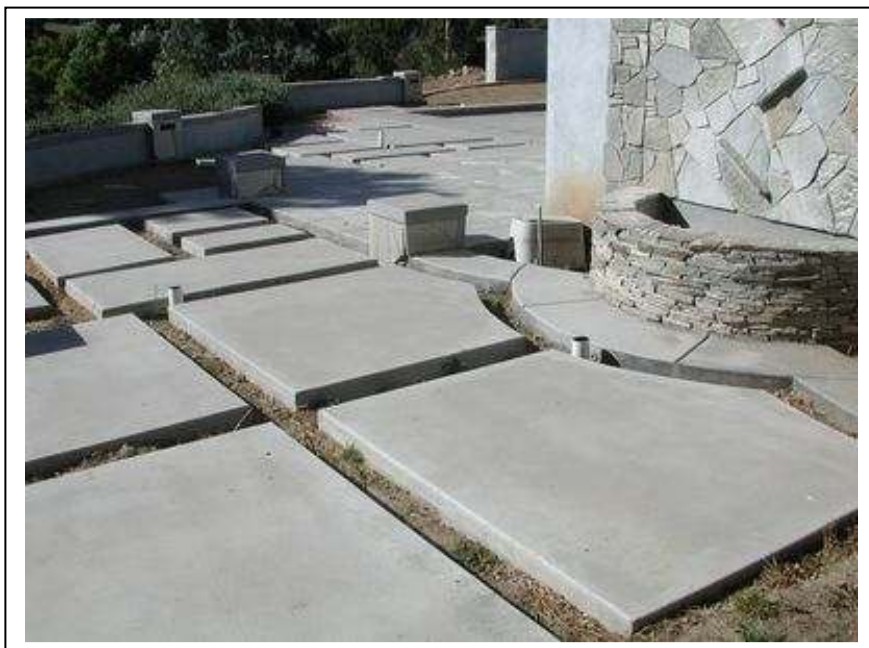
007. SC.C.2264. There is an unfinished patio at the back of the house that is a trip hazard.

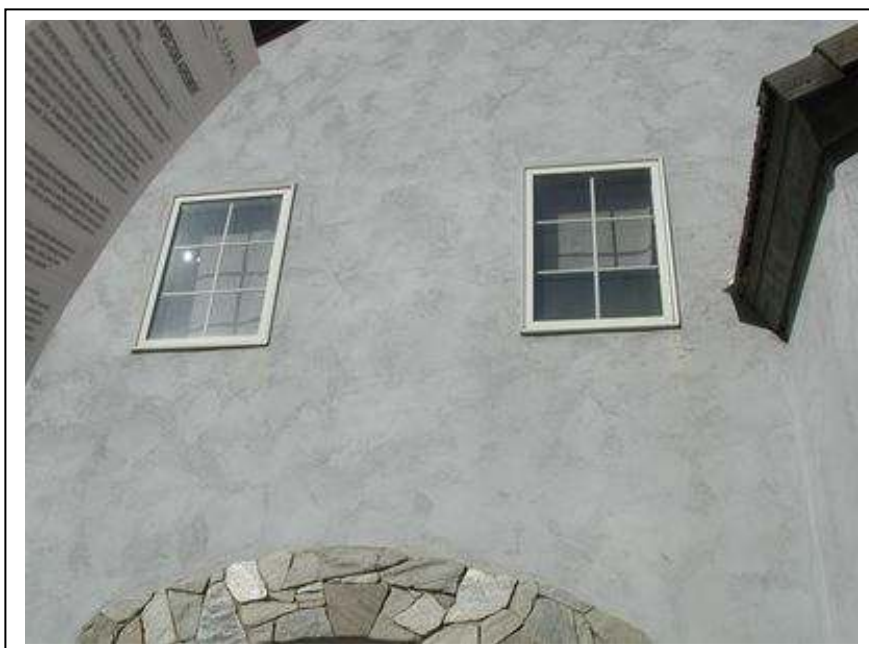
07. CR.PTR.2265. There are many small cracks in the stucco on the exterior.

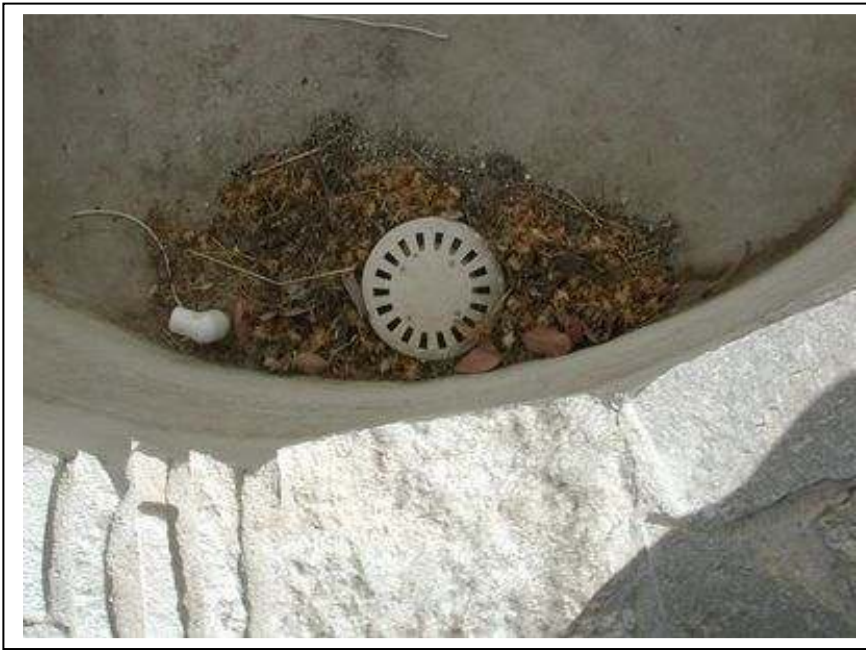
009. FE.C.2266. There is a fountain at the left rear of the house that is not operational but might be restorable.

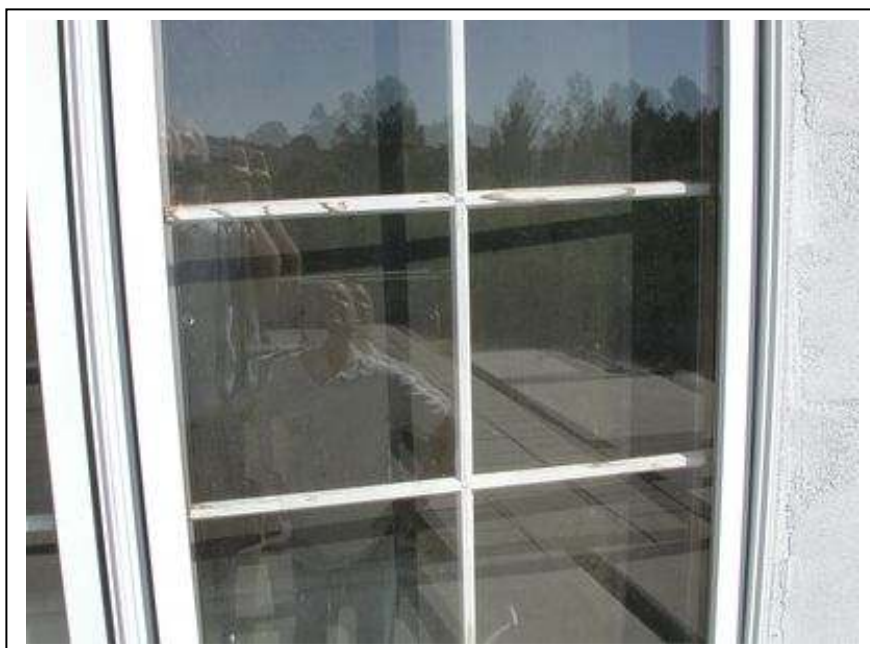
14. CR.PTR.2273. There are many windows with grids that are deteriorating from weather.

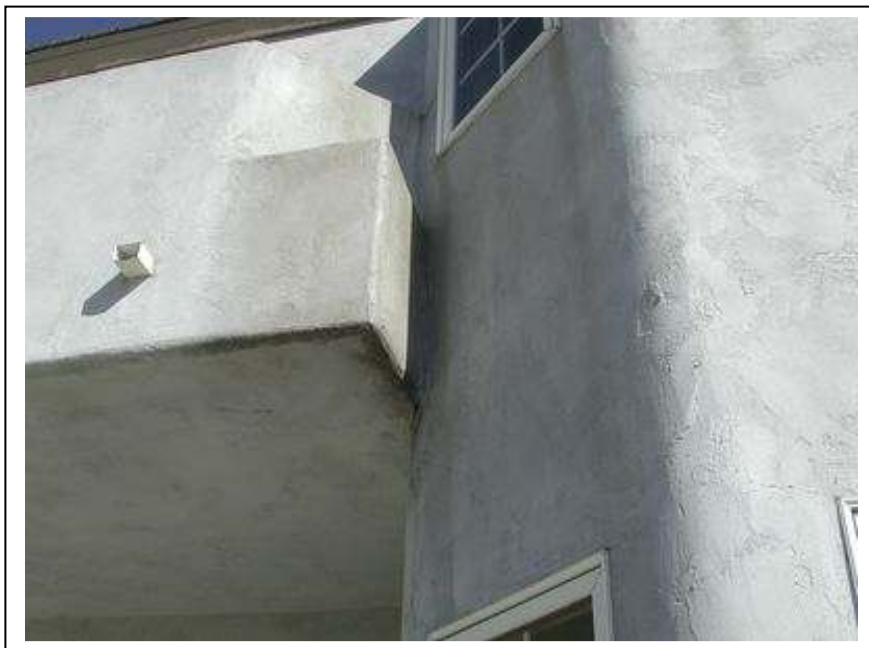
015. CR.PTR.2274. There is a rather substantial crack in stucco above the rear doorway.

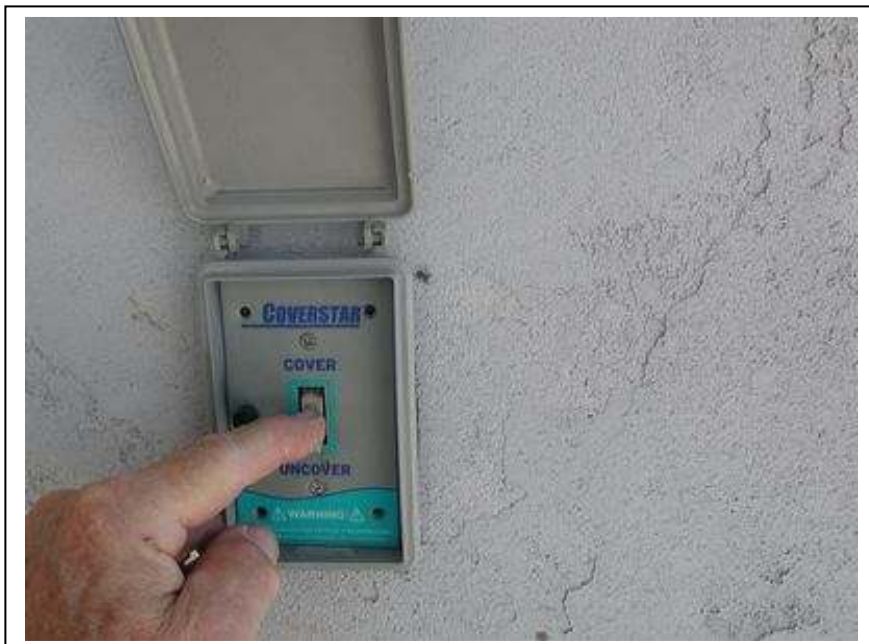
15. AA.A.2276. There is a locked switch outside the back door that can be used to cover and uncover the pool.

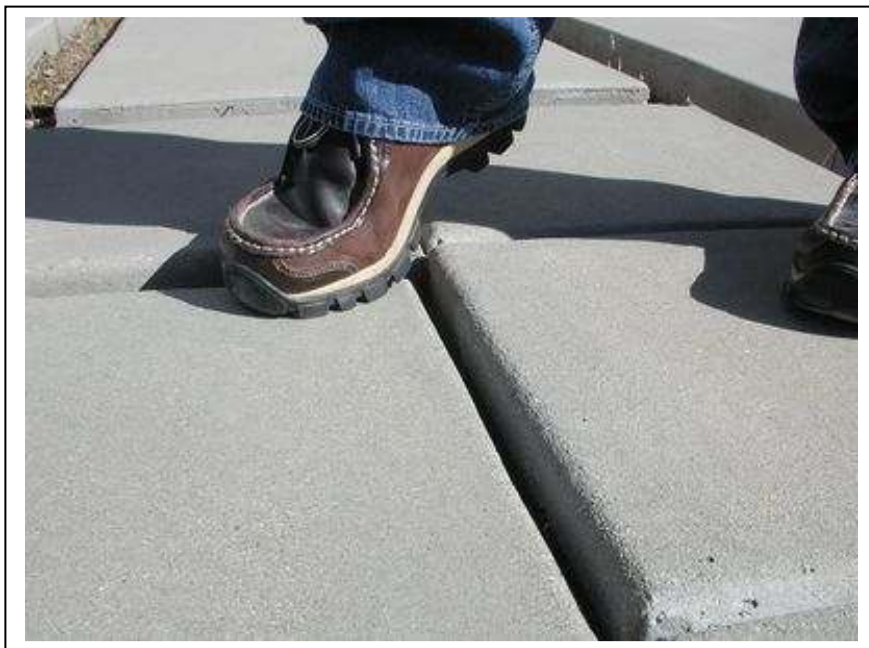
017. CR.H.2278. The decking has some concrete pieces that are loose.

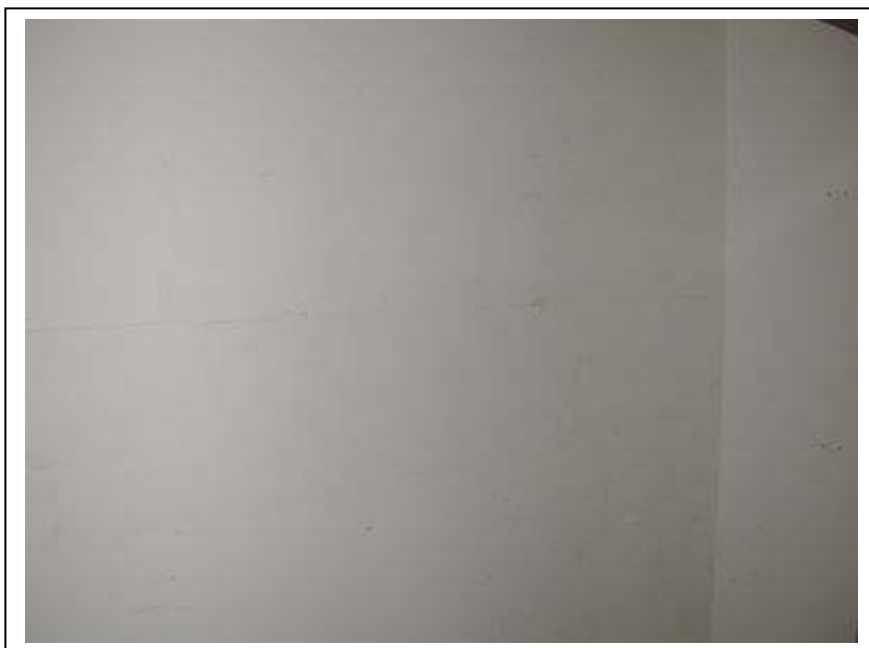
018. CR.E.2279. There are many recessed lights around the back deck that may or may not operate properly.

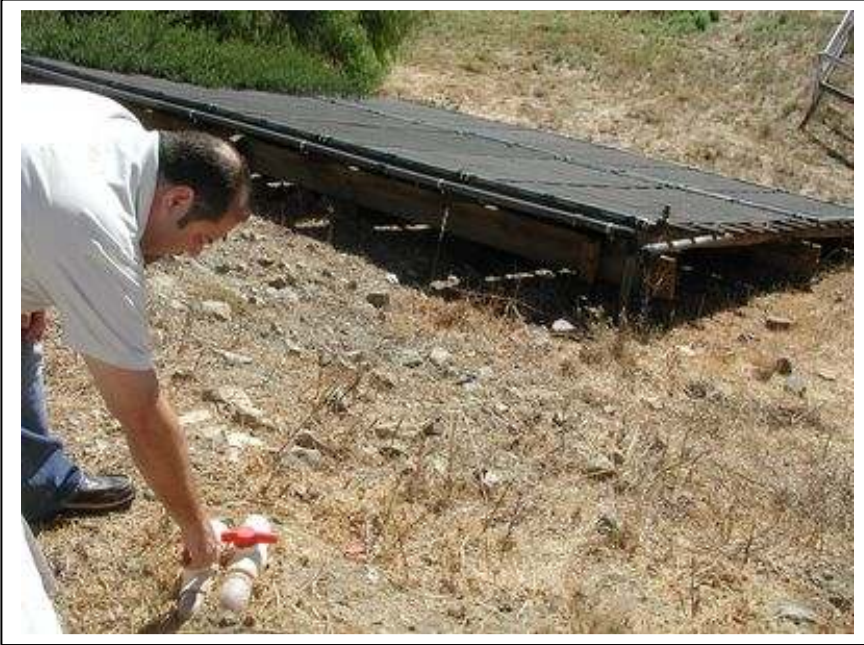
019. CR.P.2283. There are two valves that control water to the pool's solar heating system, one of which has a broken handle.

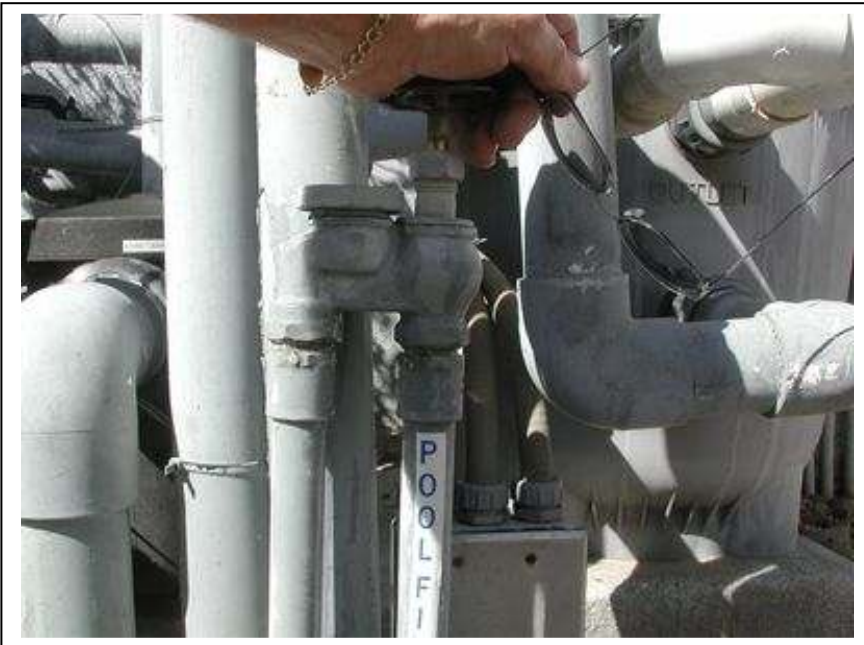
001. CR.P.2322. There is an antisiphon valve used to fill the pool and it leaks water continuously and might be defective.

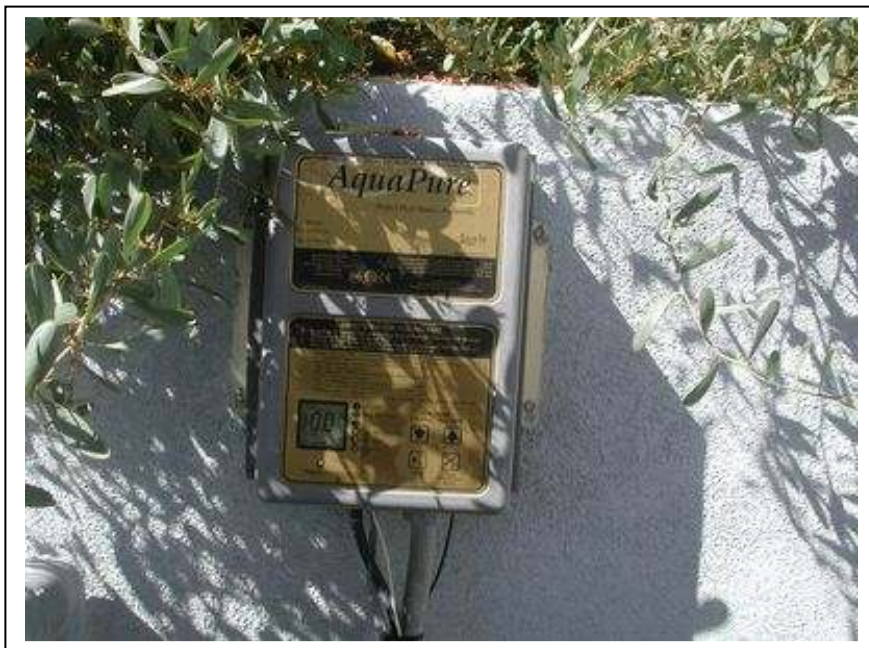
002. FE.C.2323. There is an Aqua Pure Pool Water Purifier that needs further inspection by an expert to be certain that it's operating as it should.

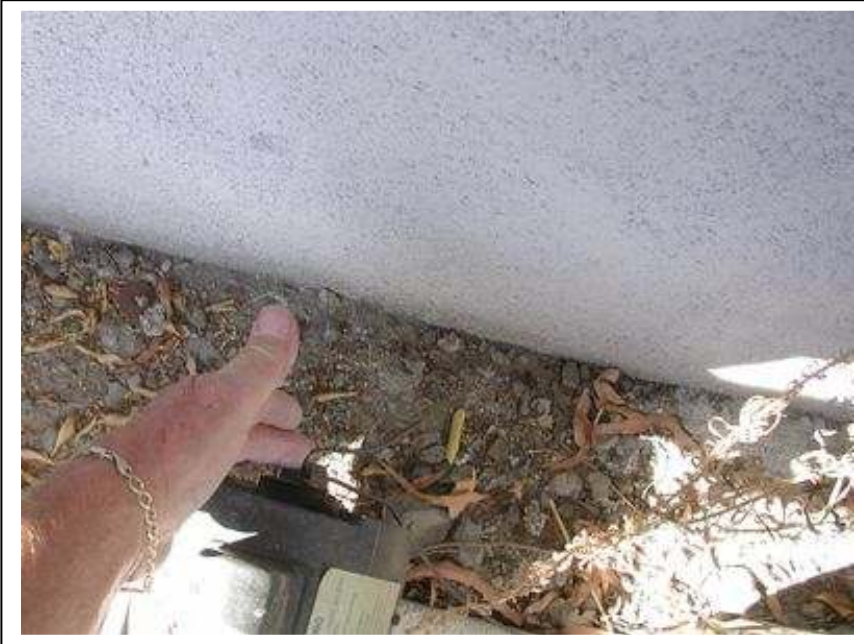
003. SC.E.2327. One pool pump motor has a ground wire that is loose at the ground lug.

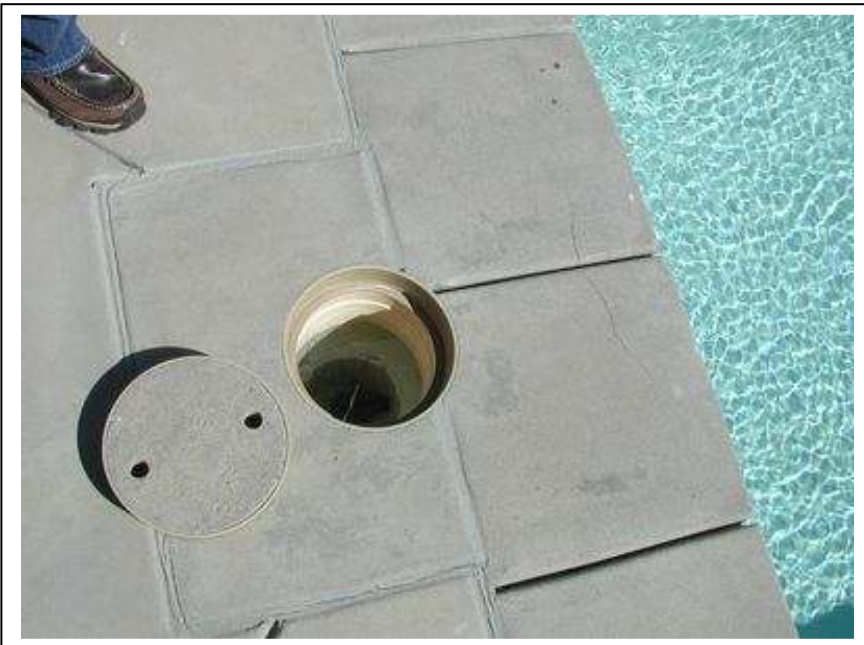
004. FE.C.2340. The pool perimeter deck is of concrete and there are no cracks in it except right at the skimmer at the shallow end, recommend review by pool contractor.

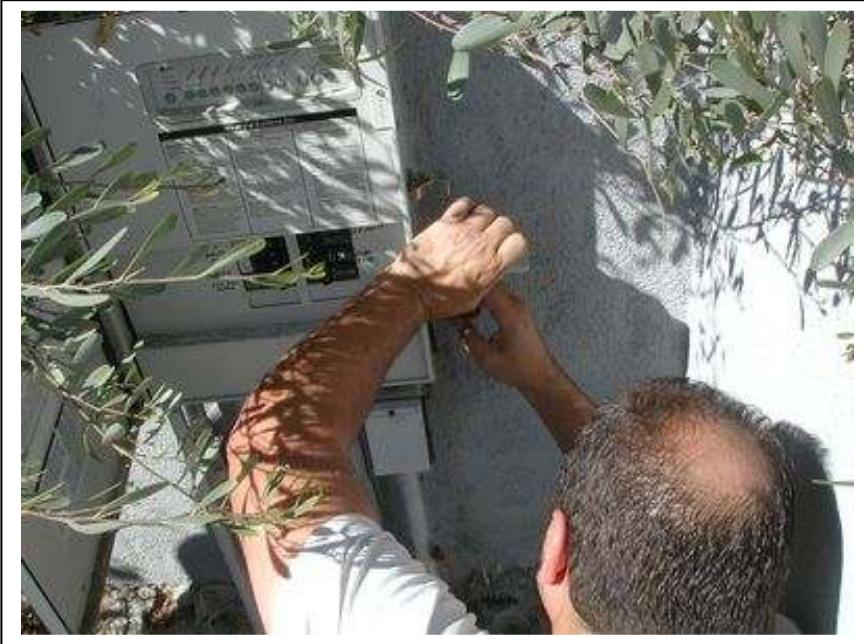
005. AA.A.2341. There are GFCI outlets at the pool breaker panel that operate properly and might or might not protect the lights, the lights did not come on when the controls were used so it could not be verified that these do protect them, recommend inspection by electrician or pool control manufacturer.

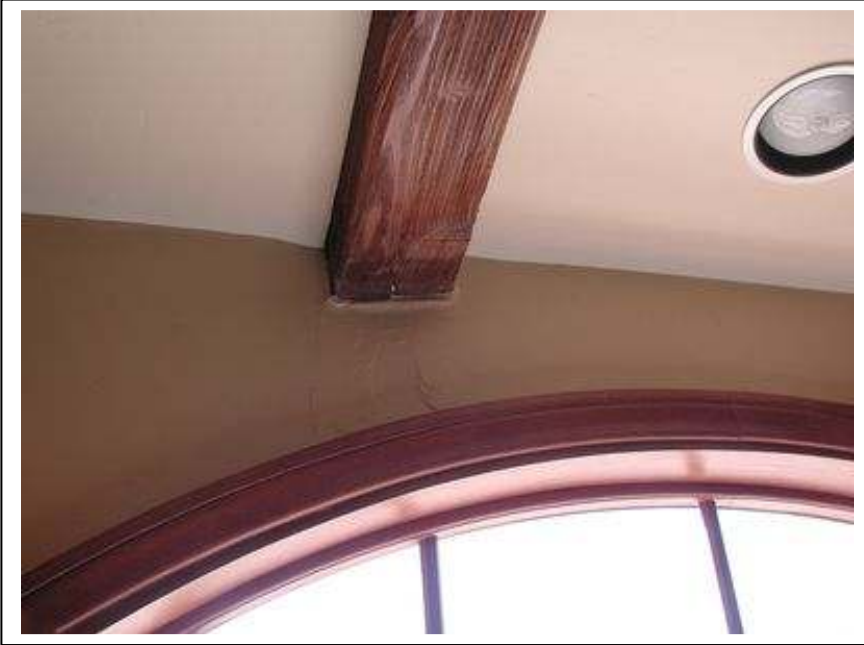
006. FE.C.2350. There is some evidence of water having dampened the wall above the kitchen sink but sources of water upstairs were not found, however there is a shower upstairs that might have leaked water through grout lines that are missing grout in the tile.

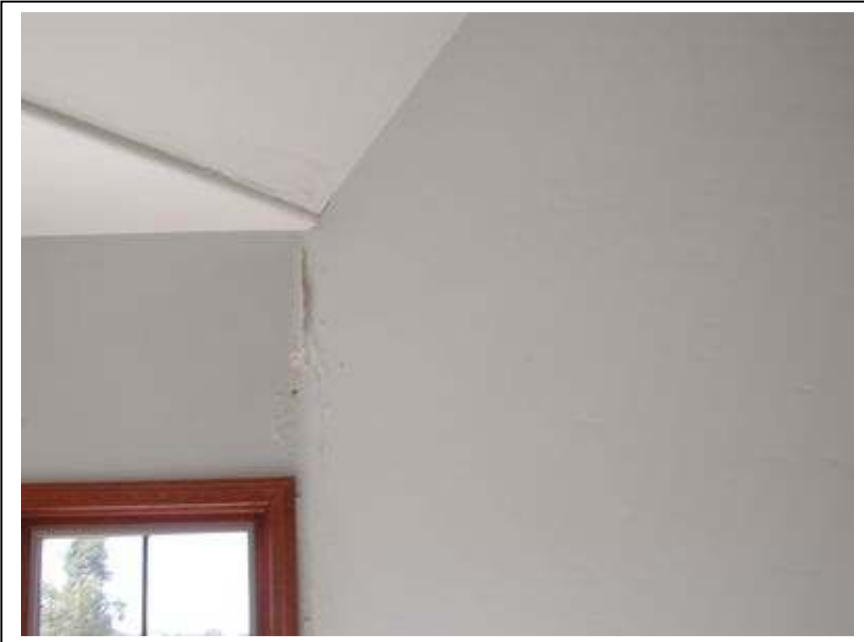
007. CR.PTR.2351. Upstairs in the master there is evidence of water having dripped through a corner and examination of the roof showed the roof to be visually intact but it's recommended a roofer take the roof apart to expose the sub roof.

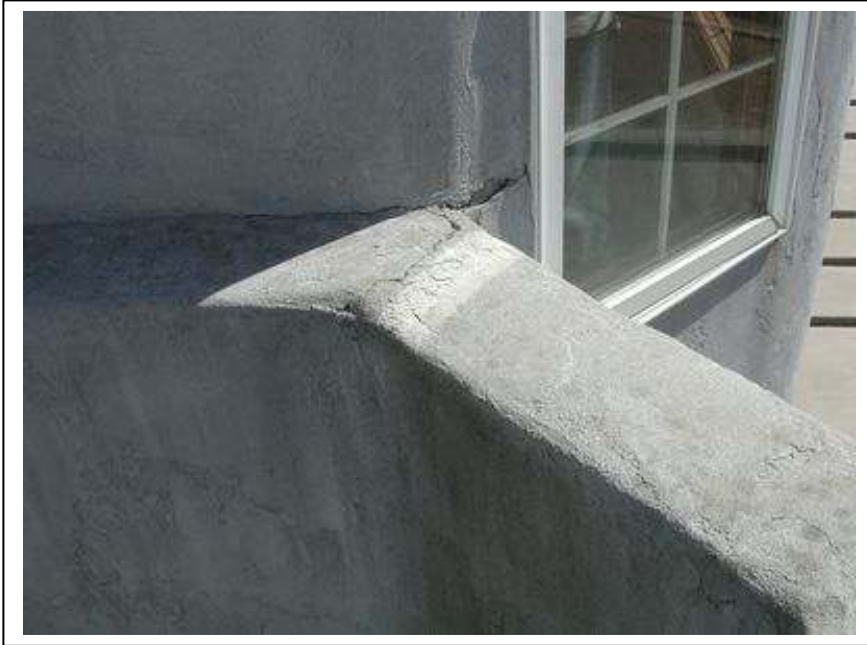
008. CR.PTR.2352. The deck off the master bedroom has some stucco on the wall and on the top of the railing that has cracks in it and could contribute to further deterioration.

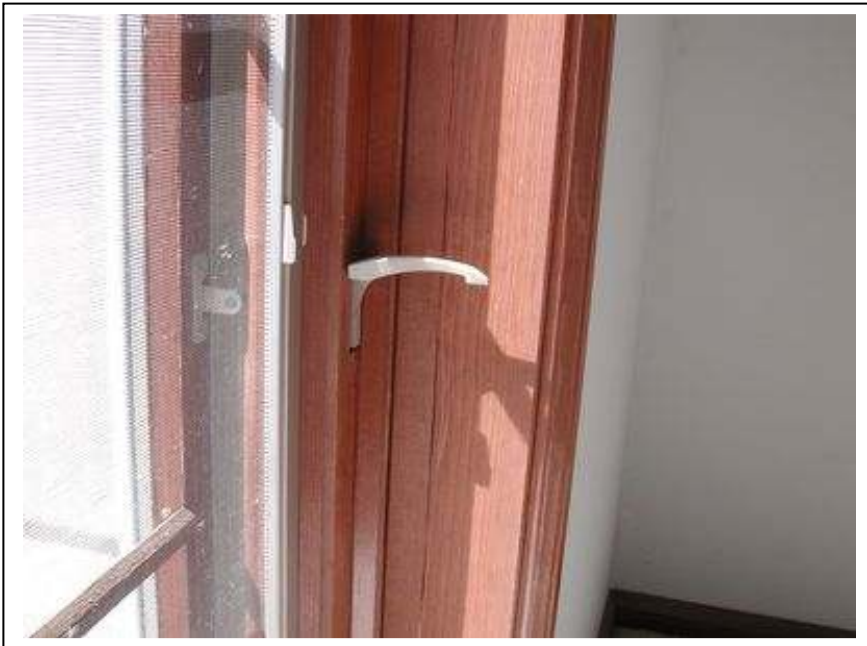
009. CR.H.2355. There are several swing out windows that would not close and latch properly.

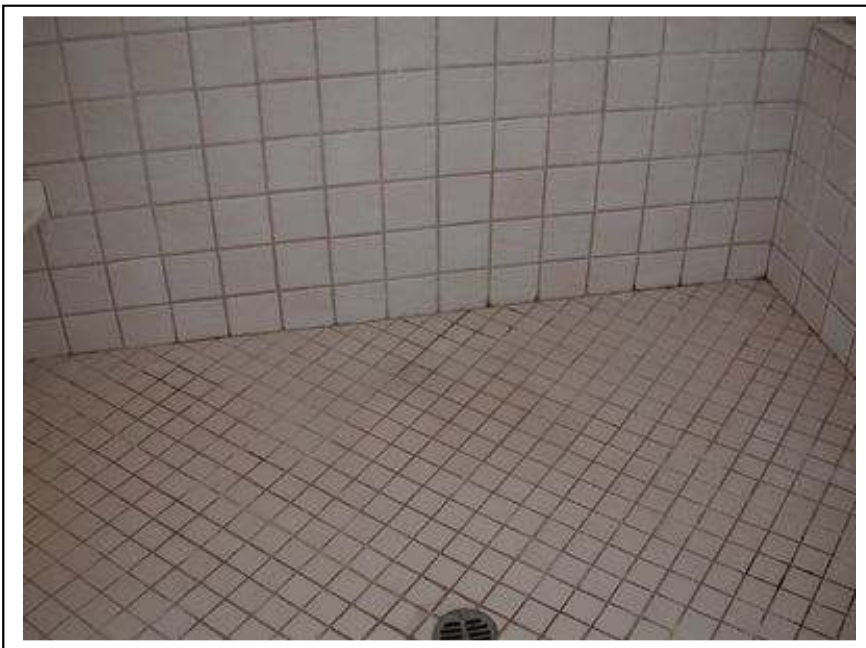
011. CR.H.22358. The master bathroom shower has grout lines that need to be renewed to be sure they don't leak.

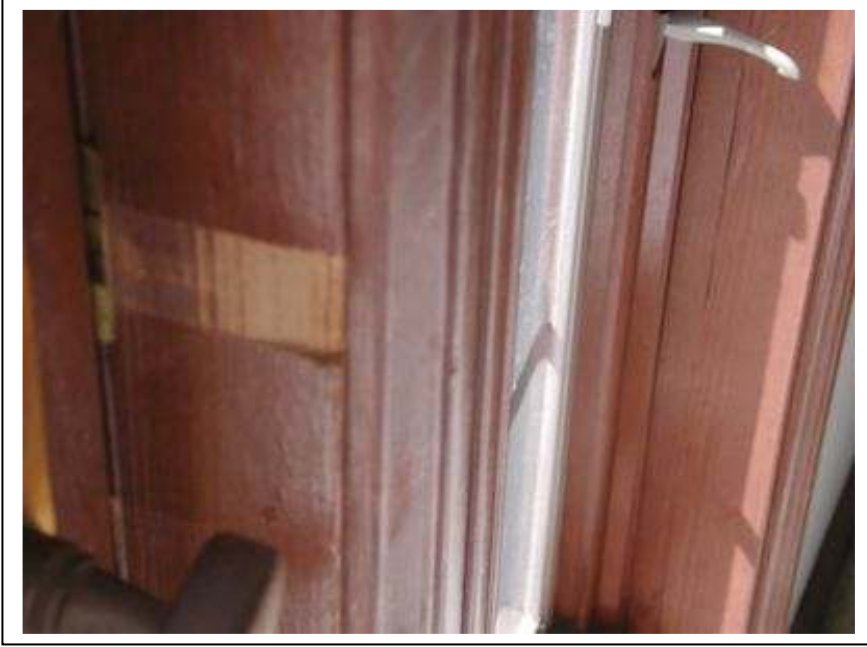
012. The master bedroom has a door to the deck that is missing a latch plate so the wood is becoming worn.

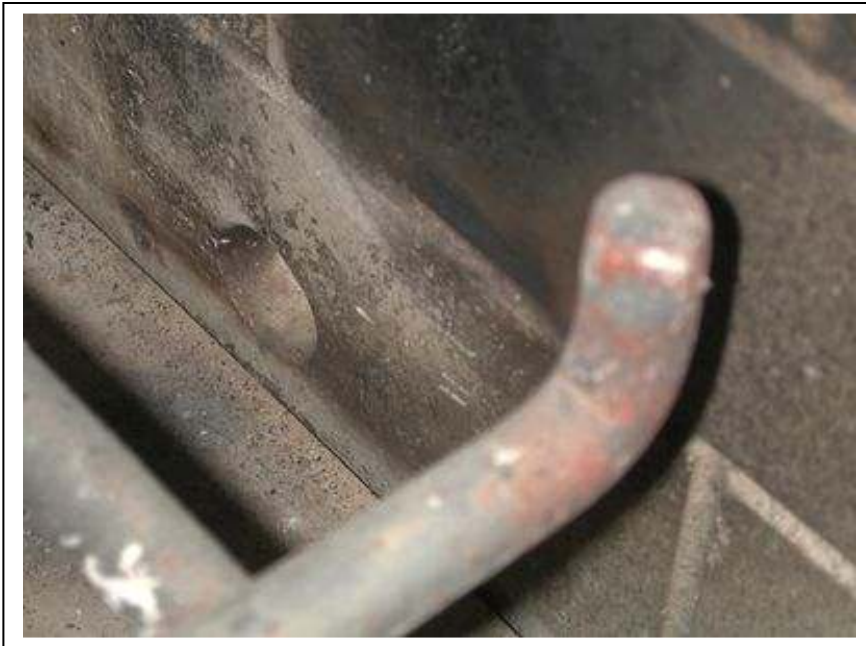
013. AA.A.2364. Not an issue. The fireplace in the master bedroom does not have a gas line attached.

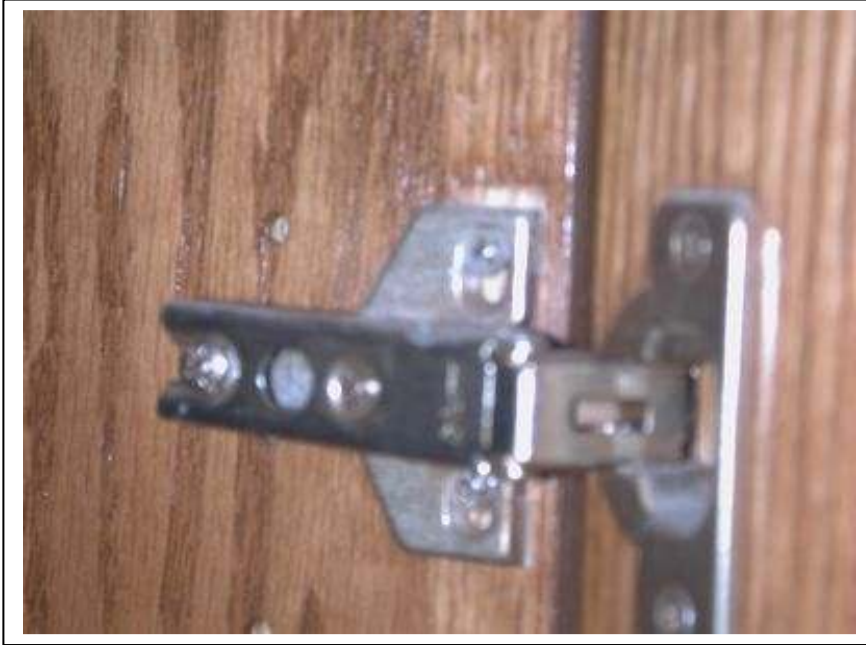
014. CR.H.2365. A cabinet in the master bedroom has a loose hinge.

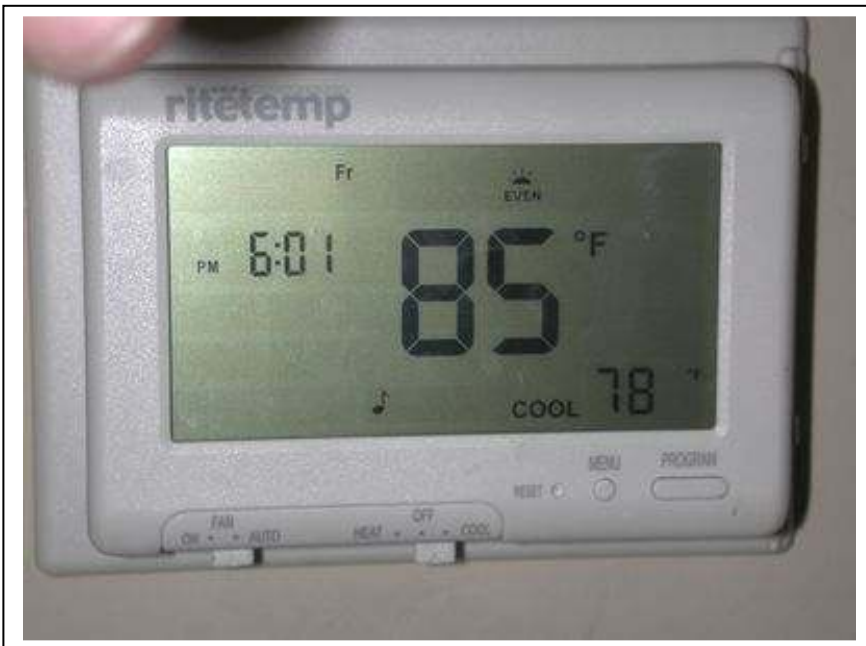
015. FE.HV.2366. The upstairs air conditioning system was set to cool and the blower went on but the unit did not cool it simply blew air through the system possibly indicating a bad condenser or low coolant level or something else.

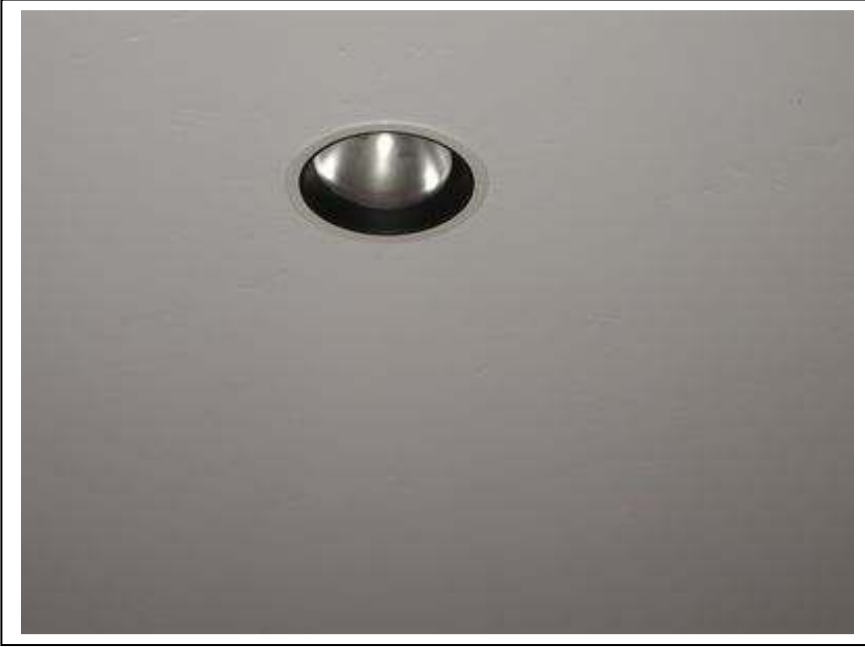
016. CR.H.2368. There are a few ceiling lights that don't operate properly.

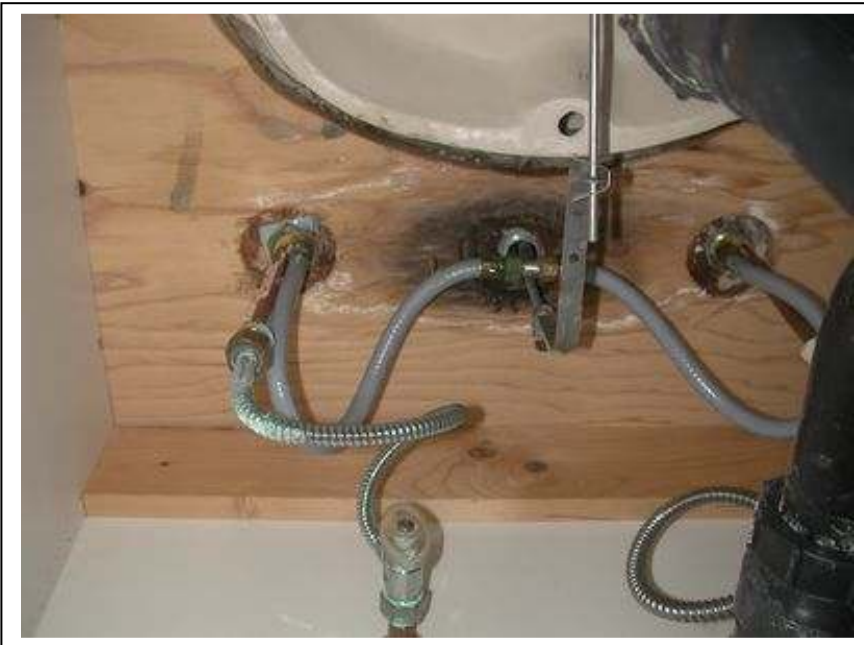
019. CR.H.2373. The right sink in the master bath had a leak around the spout and that water has damaged the wood sub cabinet and dripped on the base of the cabinet damaging the base.

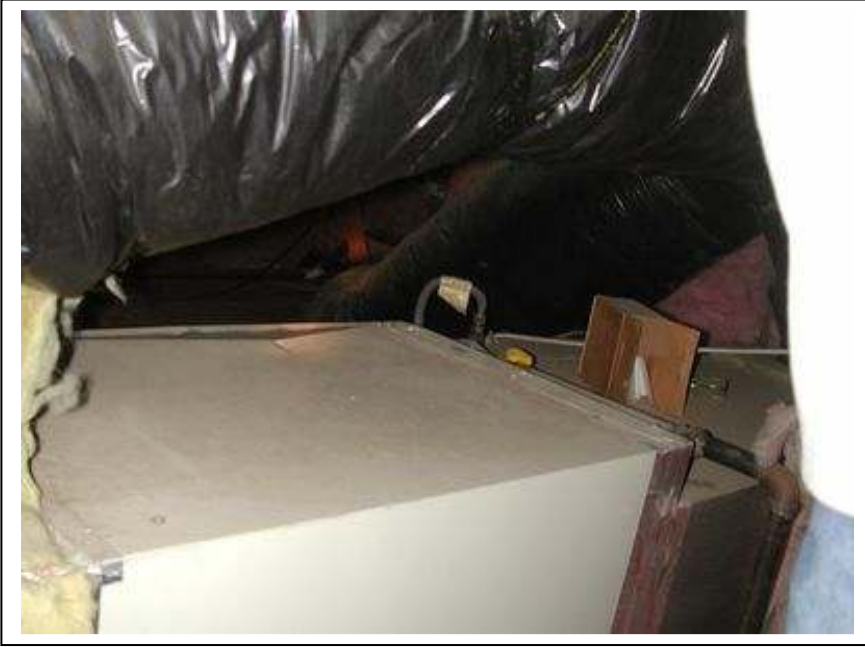
020. CR.HV.2377. There is an air conditioning system in the attic that has been damaged opening up a gap in the box that allows air to escape into the attic.

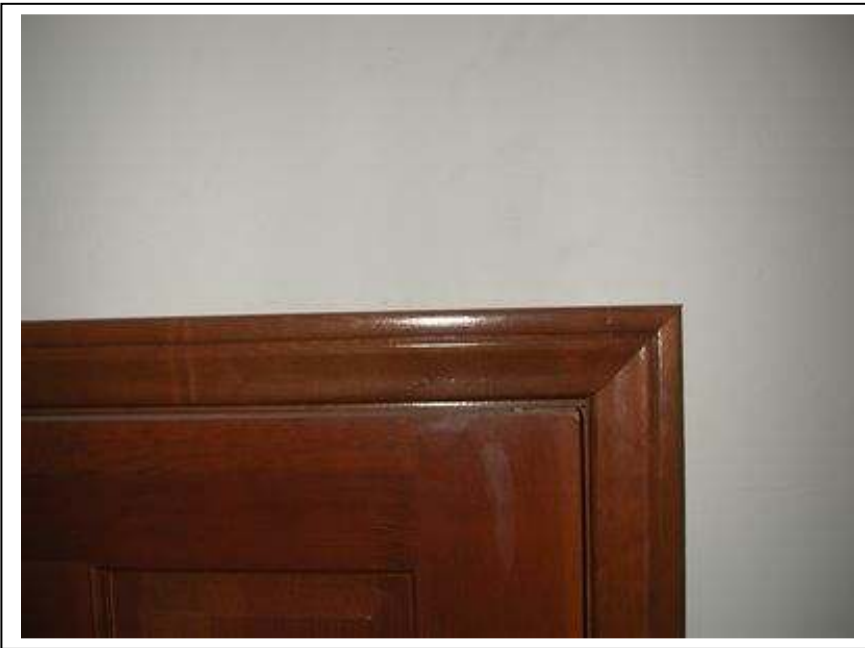
021. CR.H.2380. One bedroom door interferes with the frame and does not close properly.

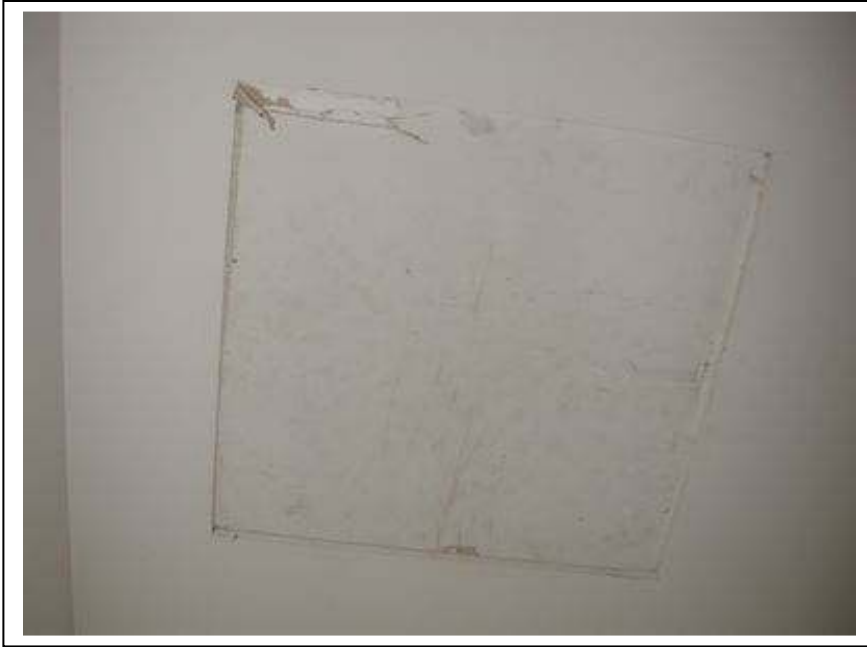
027. CR.PTR.2392. The entrance to the attic in the master bedroom closet has a damaged surface.

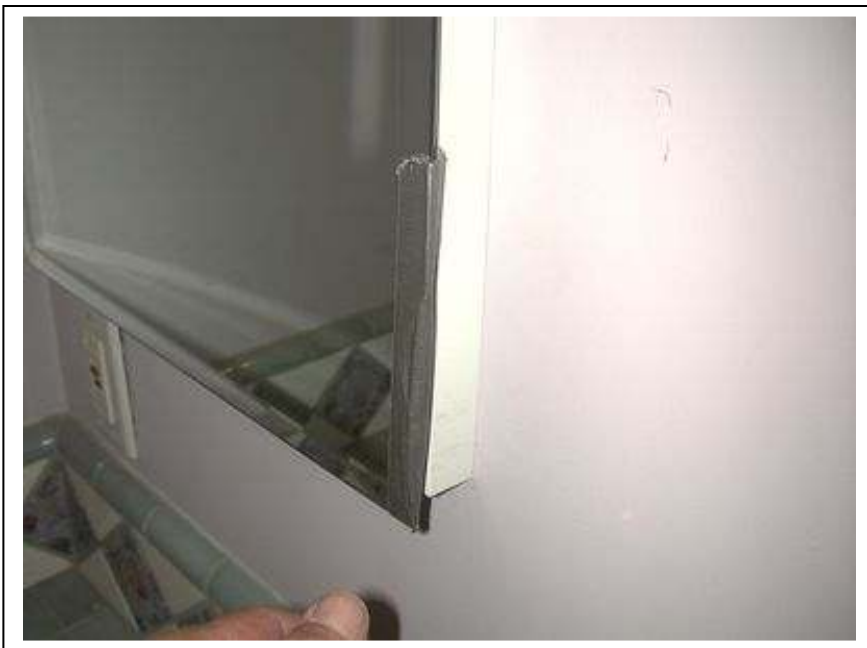
028. CR.H.2396. One bathroom has a broken mirror on the cabinet.

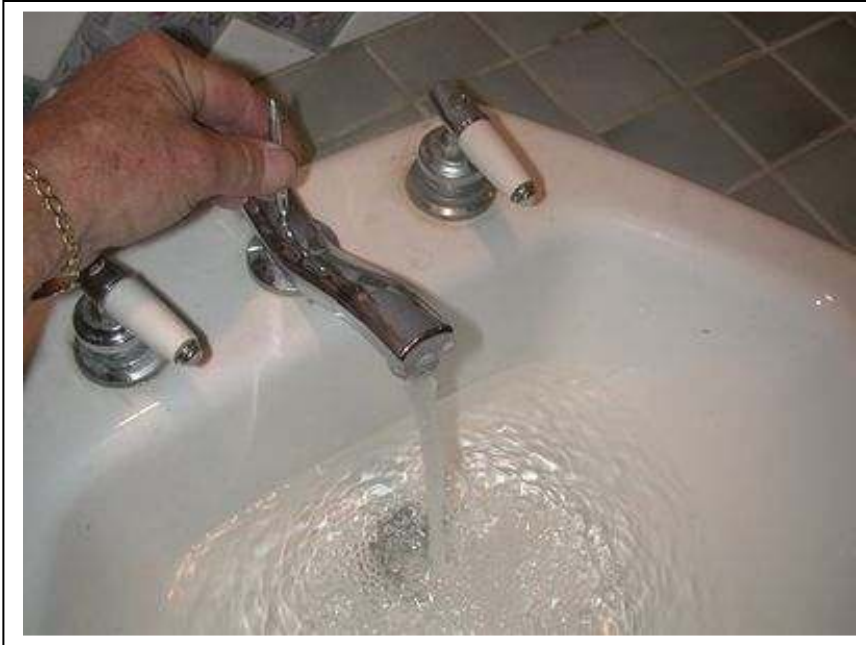
029. CR.H.2397. One bathroom has a drain stopper rod that's missing a handle.

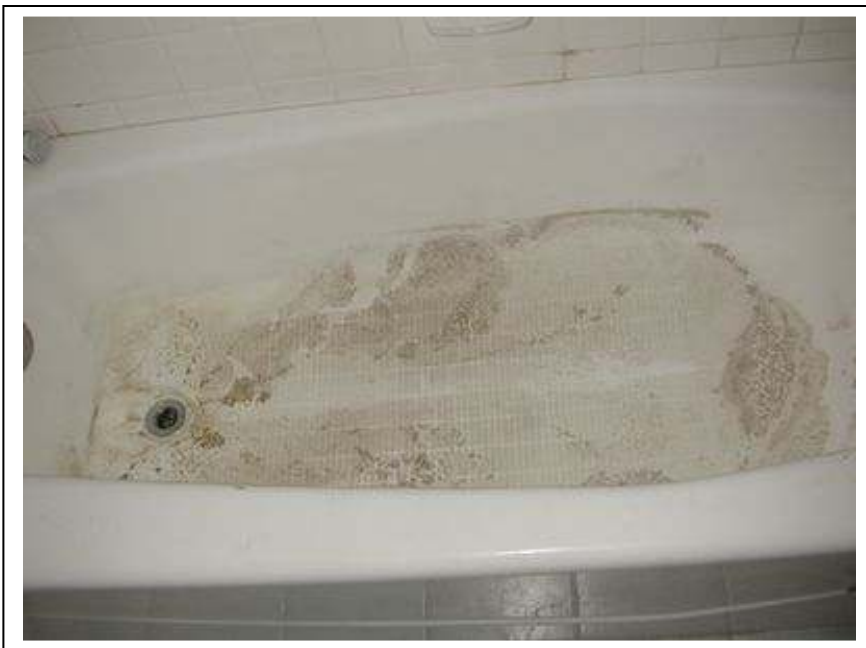
030. CR.H.2400. One bathroom has a tub that does not drain properly.

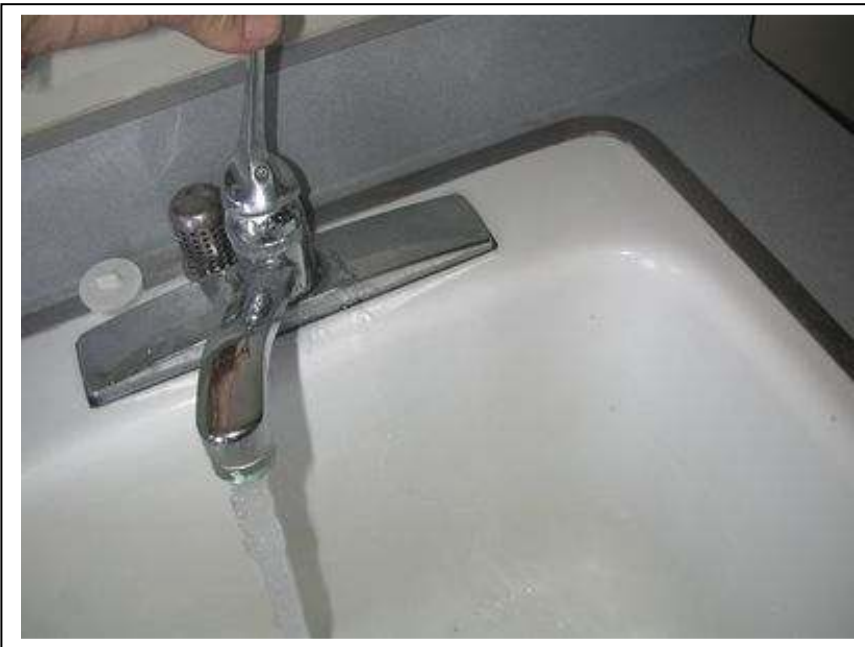
032. CR.P.2407. The water faucet in the service room leaks from the stem when it's held up.

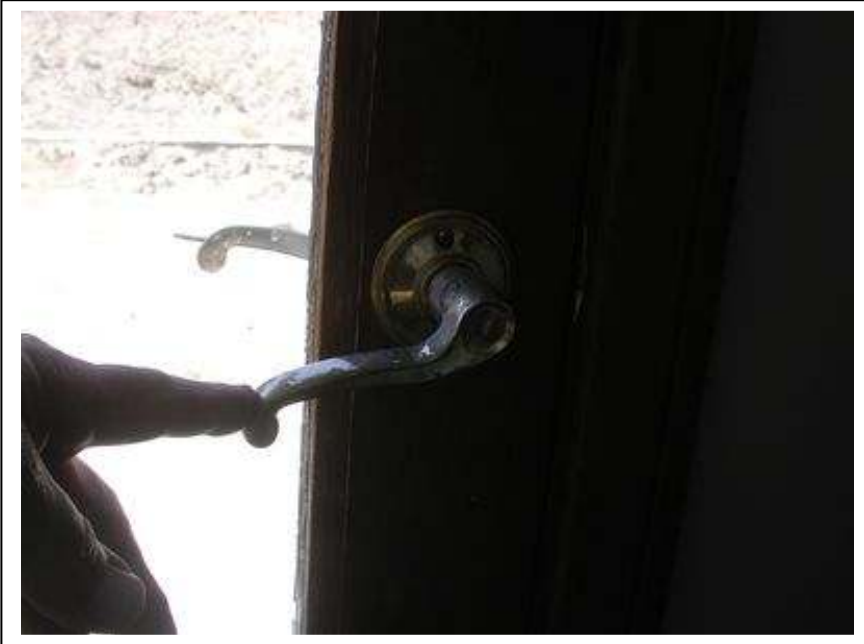
033. CR.H.2409. The side door off the service room has a door handle that is apparently worn and not set properly.

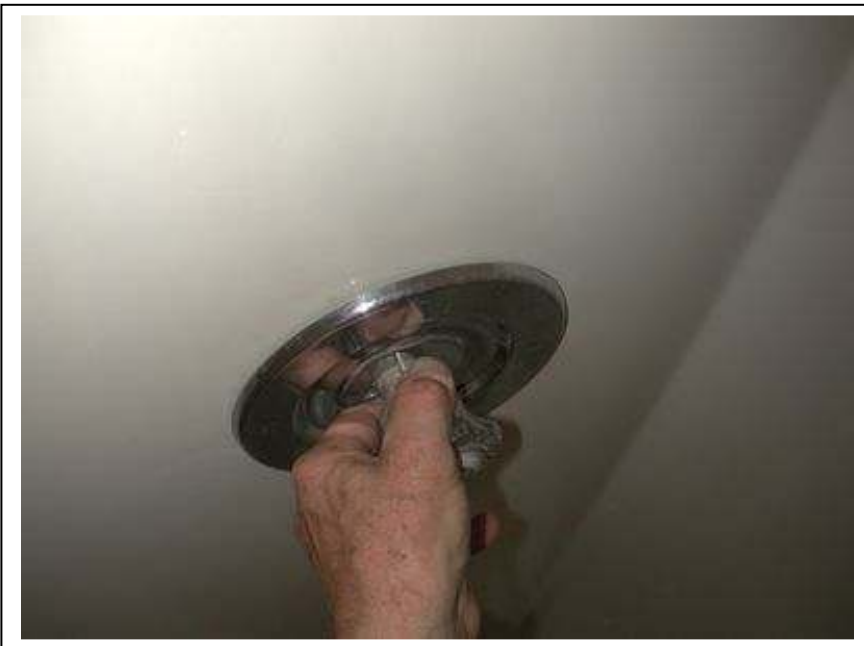
034. CR.P.2410. The stall shower off the service room has a valve that is not mounted solidly and it pulls slightly out of the wall.

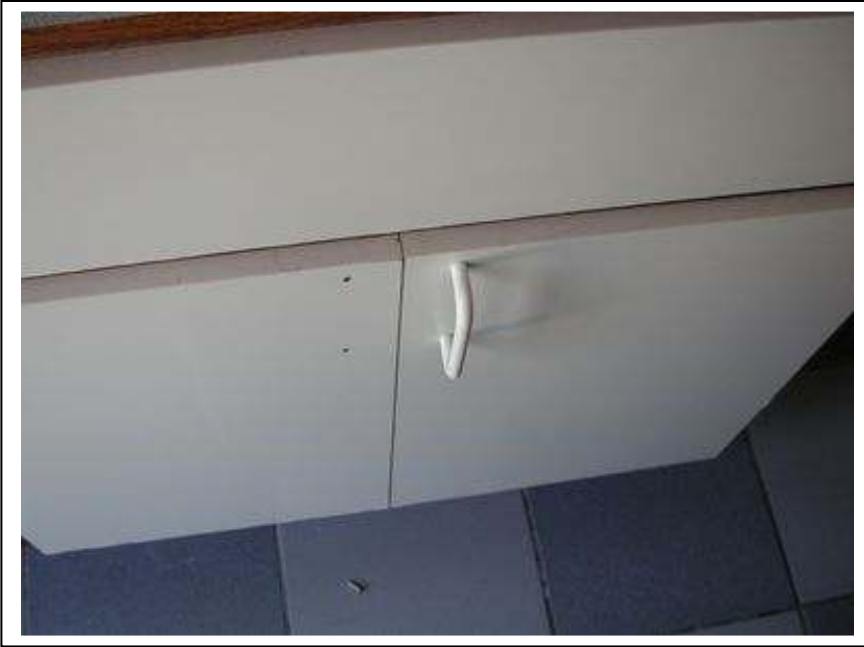
035. CR.H.2411. The one cabinet in the service room is missing a handle.
