**Guaranteed Home Inspections
800 579 5018**

**HOME INSPECTION REPORT
By Kurt Shafer
Inspector of Properties**

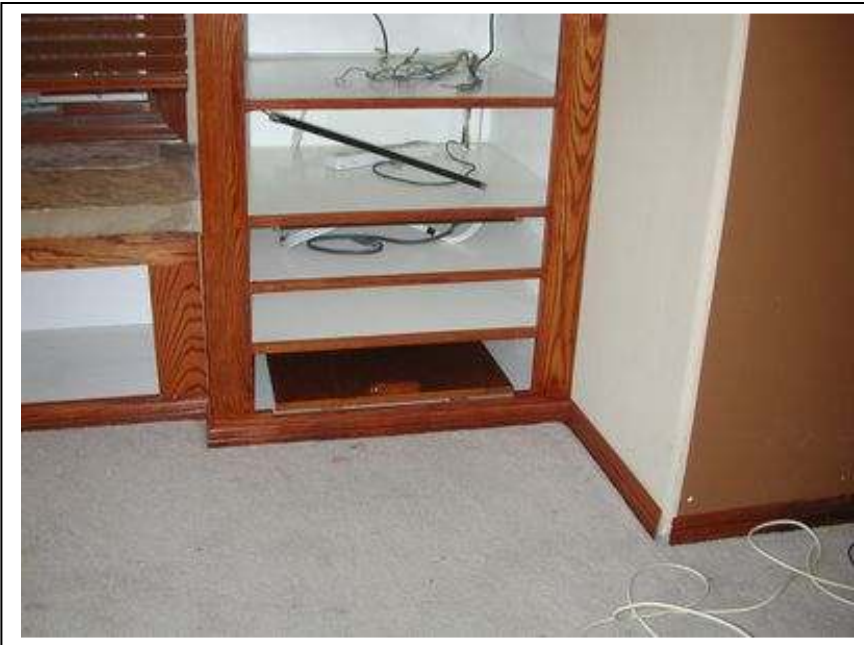
036. CR.H.2413. There are cabinets in the house that are missing doors and there is a corner piece missing from the floor baseboard.

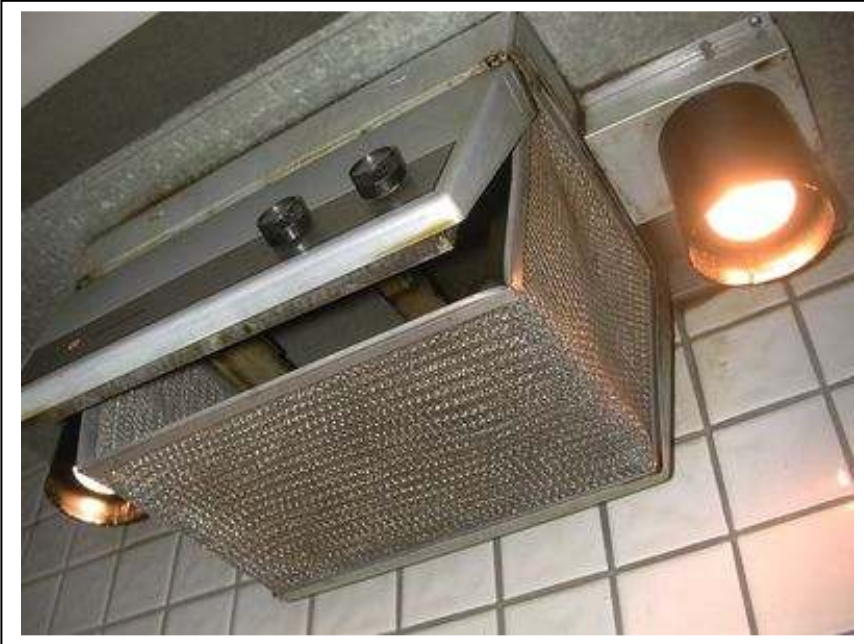
037. CR.H.2414. The fan and blower and filter assembly above the kitchen range is in disrepair.

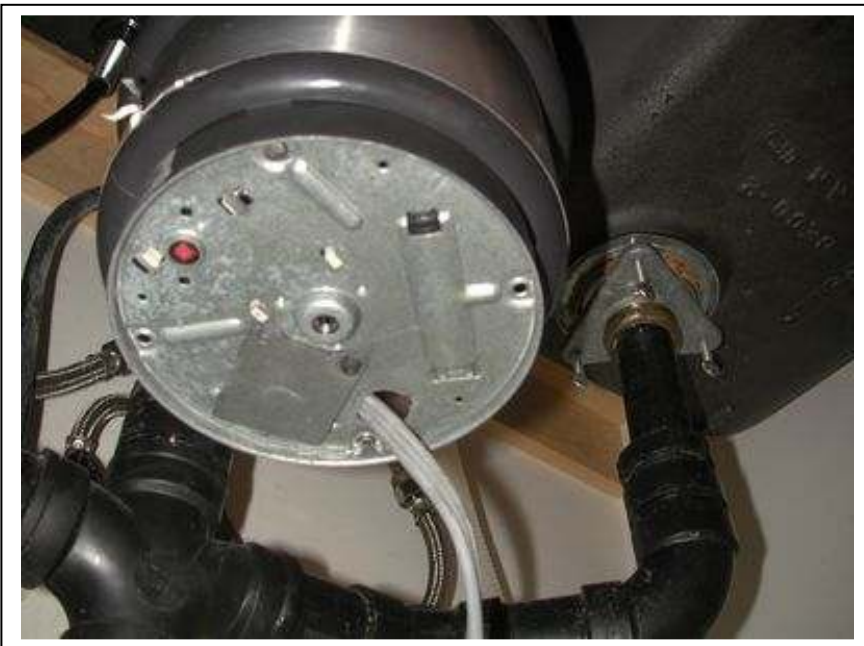
038. CR.P.2417. The kitchen garbage disposer has an AC wiring missing a clamp.

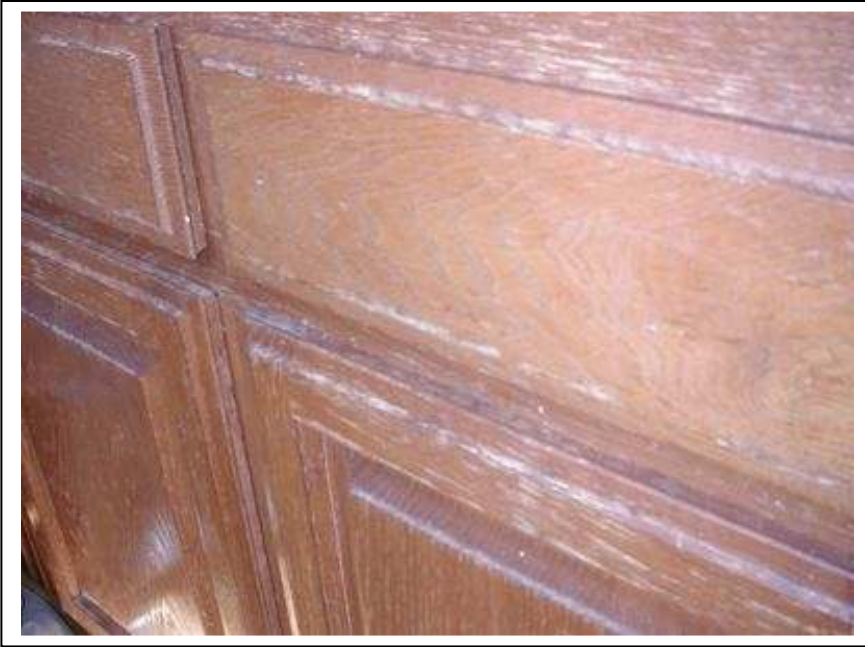
039. CR.P.2418. The kitchen cabinets are worn.

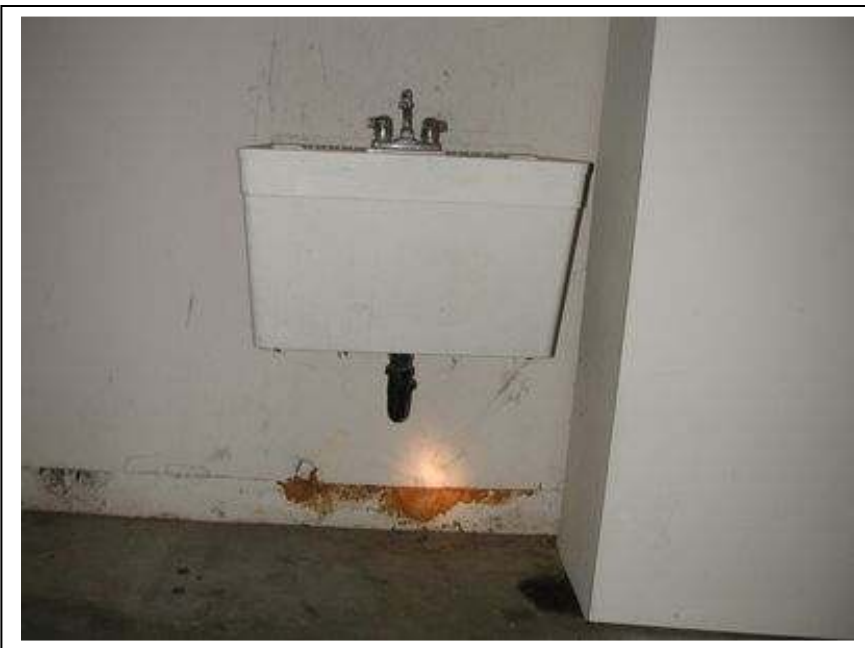
040. CR.H.2420. There is a water basin in the garage that is mounted at a tilt.

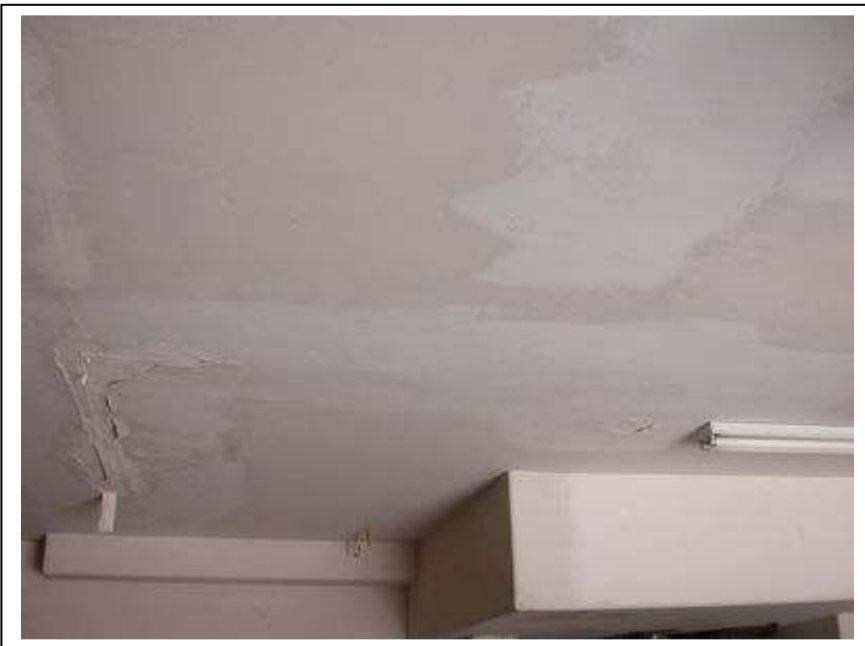
042. CR.PTR.2423. There is a significant amount of water damage to the ceiling of the garage just under a shower above.

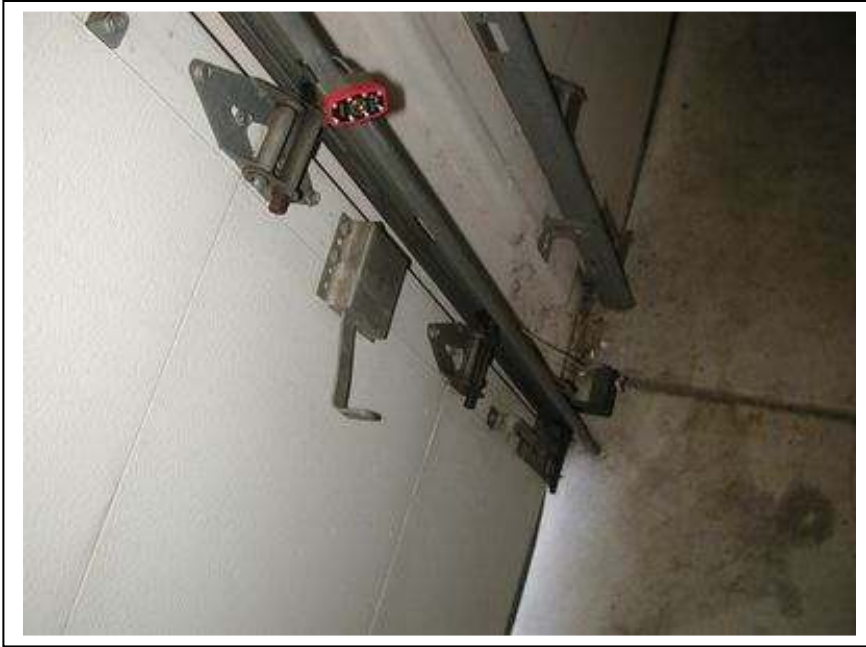
043. FE.C.2426. The center garage door could not be tested because it had been padlocked.

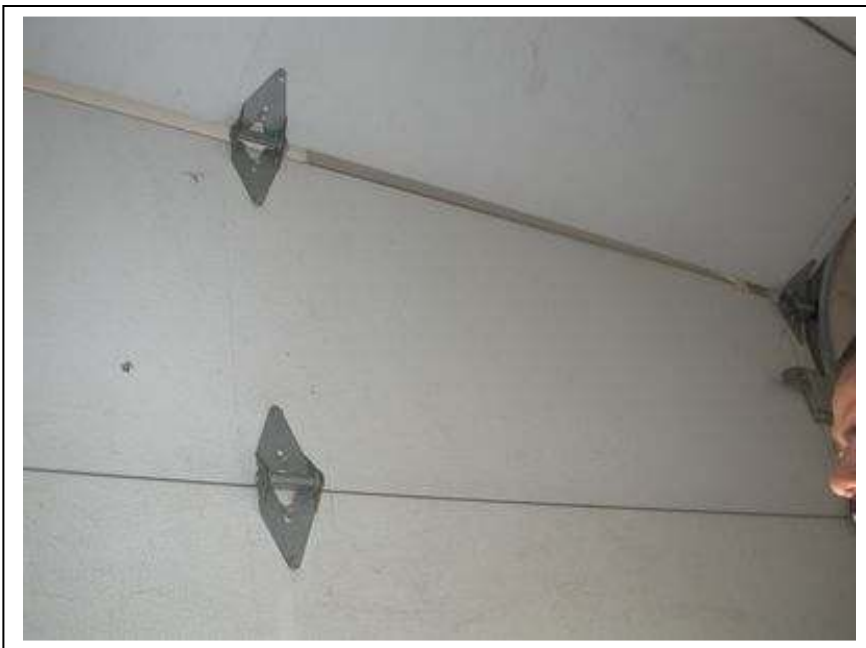
044. CR.H.2427. The garage doors are missing handles on the inside.

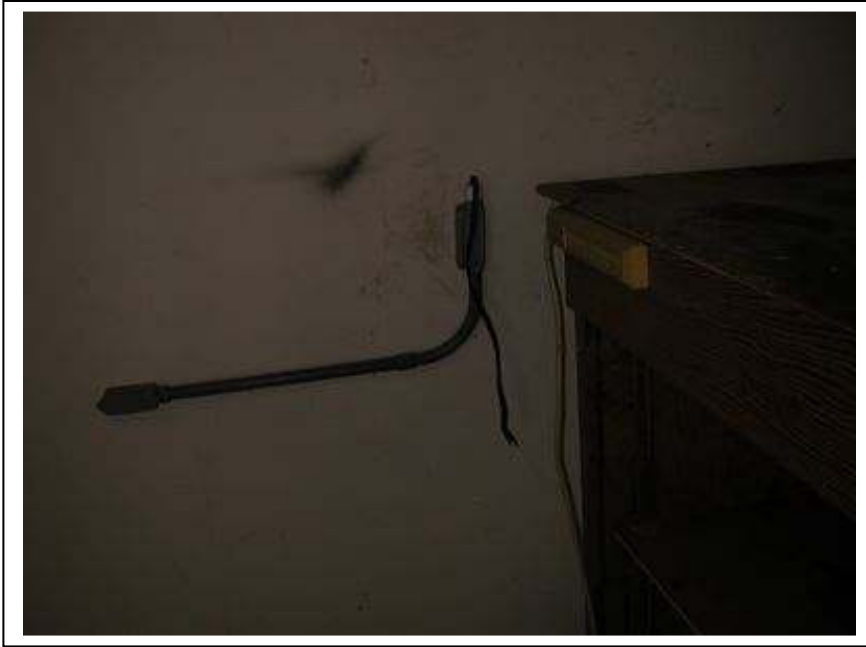
045. SC.E.2428. There is an AC cord hanging loose in the garage that might be electrified.

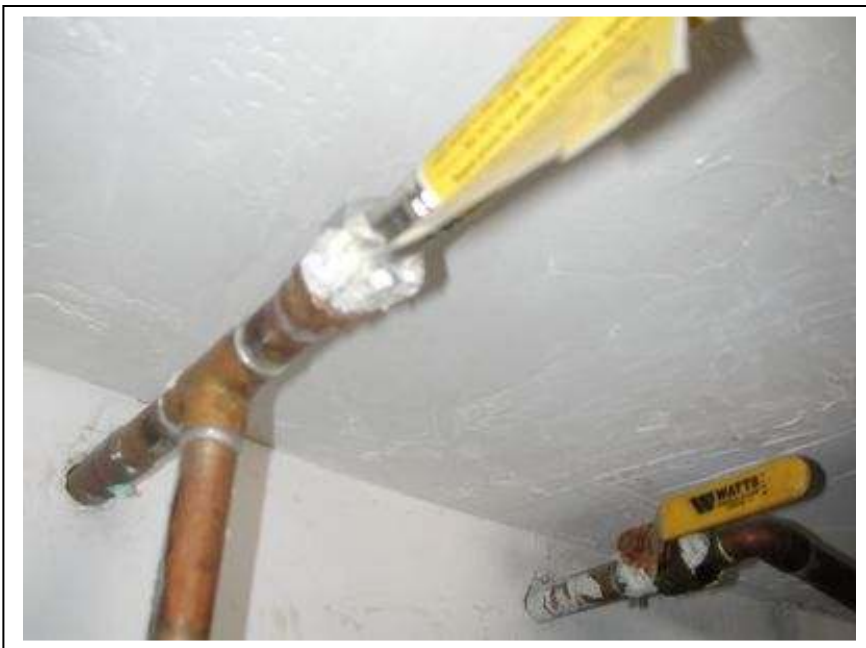
046. FE.P.2430. There is a fitting over the water heater in the garage that is corroded.

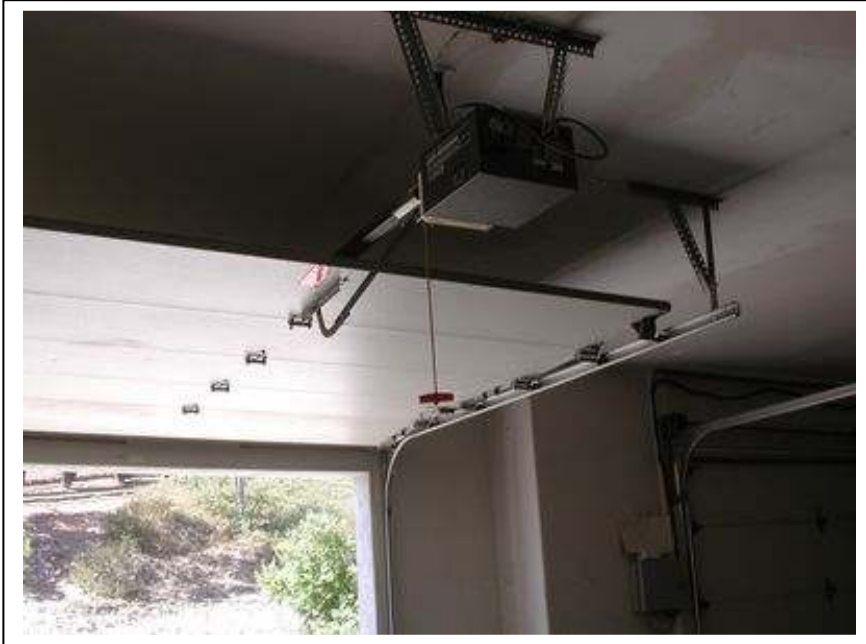
047. CR.H.2434. The left most garage door when in the garage is misadjusted and does not go down easily.

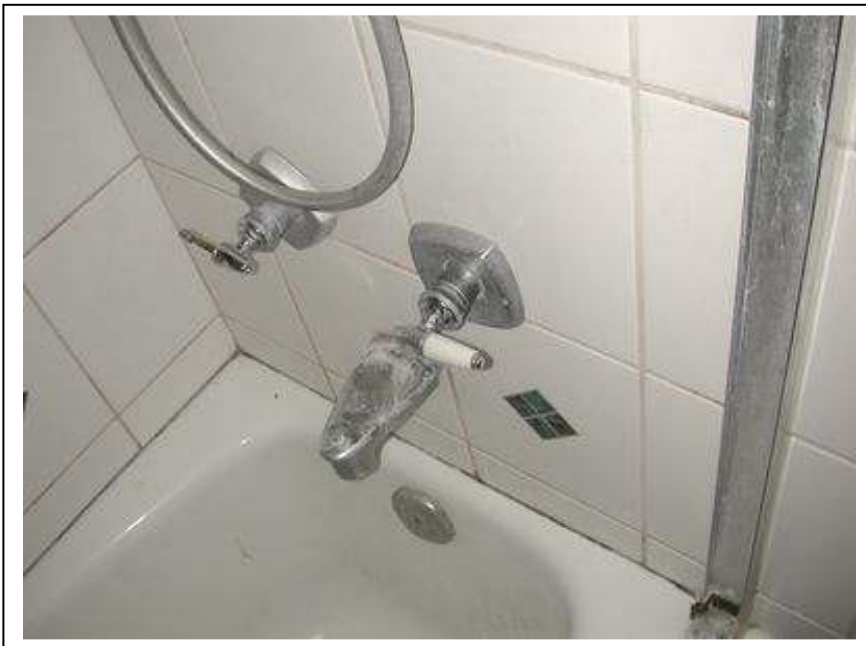
048. CR.P.2435. There is a tub shower that is missing a handle.

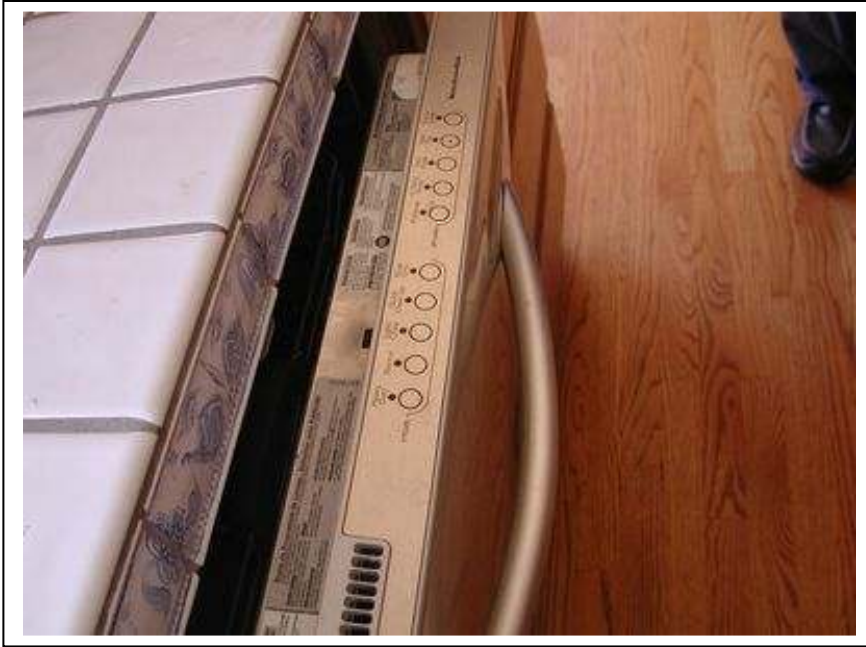
049. CR.H.2436. The kitchen dishwasher door would not latch closed and operate.

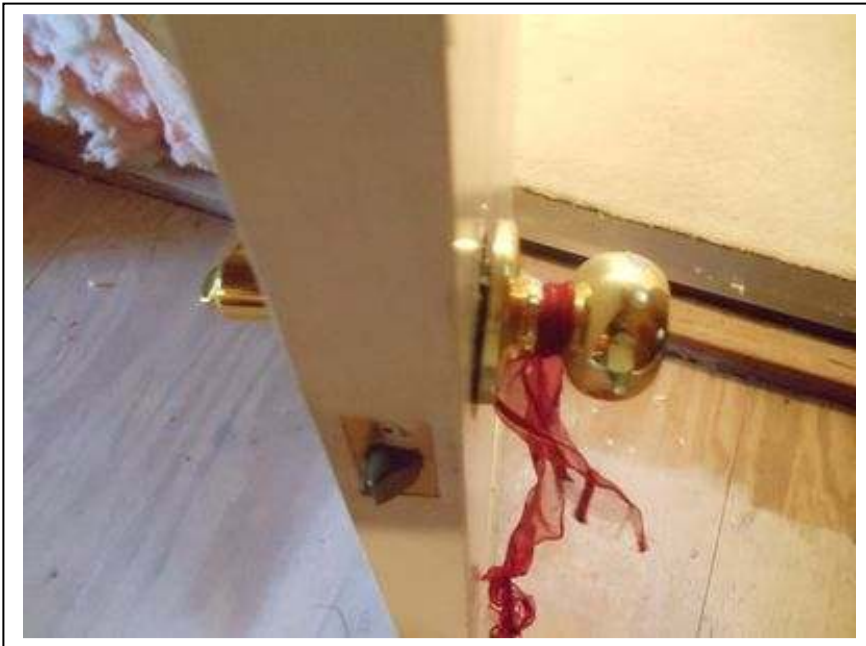
Figure 001. CR.H.2437. Door handle loose at attic above garage

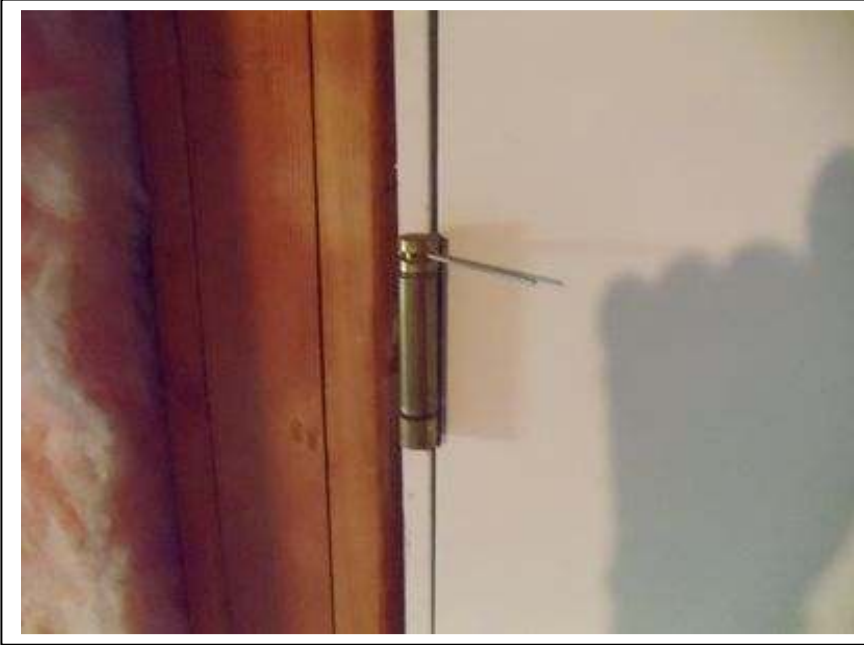
002. CR.H.2438. Spring assembly broken on door at attic above garage

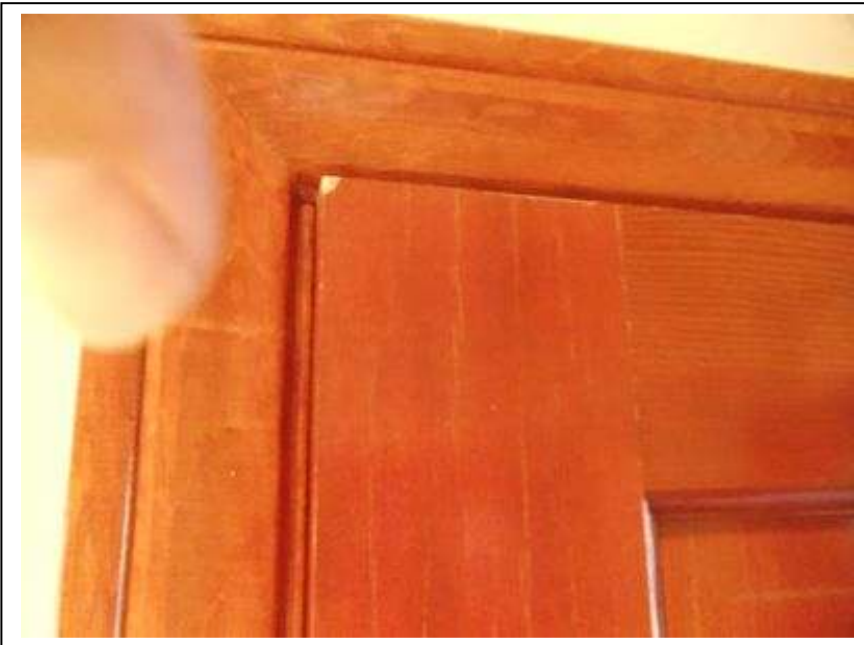
003. CR.H.2439. Bathroom door in secondary restroom is sticking, requires adjustment

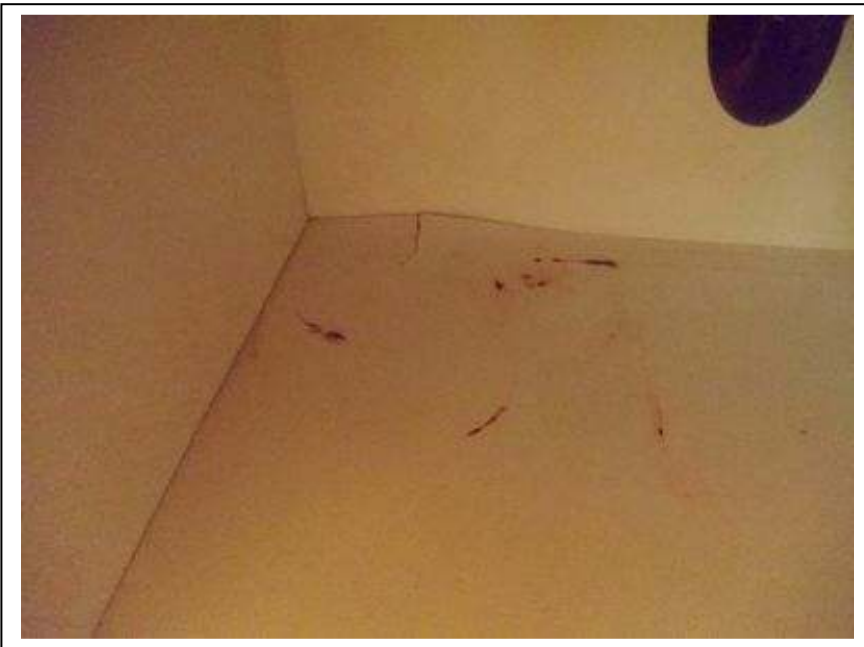
006. CR.PTR.2441. Signs of water damage found underneath sink in secondary bathroom, however there are no current leaks

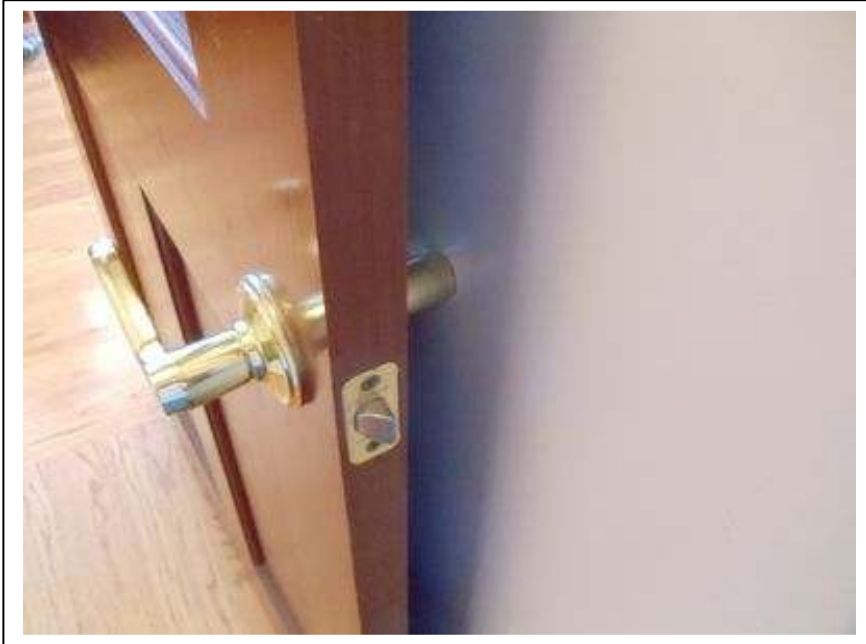
**009. CR.H.2442. Pantry door missing door stopper
END**
